# **City of Charlottetown Brook Trout Conservation and Protection Plan**

**April 30, 2015**

**Prepared for Ellen's Creek Watershed Group Inc 2014**

**Megan Harris, Lorax Environmental, St Catherine's, PE**

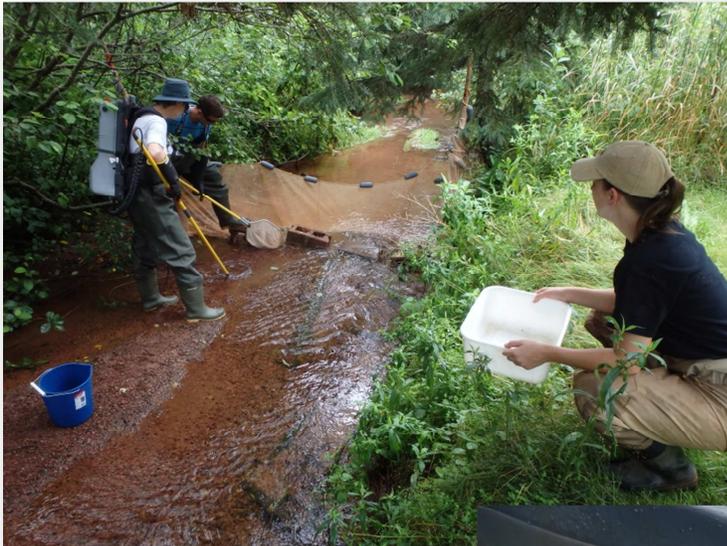
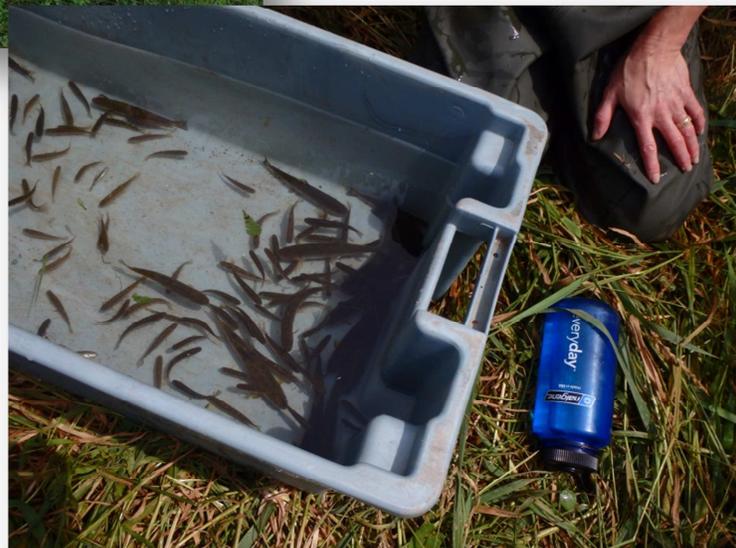
*Figure 2.1 Electrofishing Ellen's Creek in the summer of 2014, a joint initiative of the Ellen's Creek Watershed Group Inc and the PEI Department of Agriculture and Forestry, Fish & Wildlife Division (Photos courtesy of Norman Dewar)*

An electrofishing survey conducted roughly midway up the western branch suggests there is a resident population of brook trout in these upper reaches (Figure 2.1). Juvenile brook trout were present at a density of 85 per 100 m<sup>2</sup>. Rainbow trout (*Oncorhynchus mykiss*), an introduced and potentially invasive species, was not present. The riparian margin here is a mix of mostly coniferous trees and grasses that provide excellent overhead and stream-bank cover. Frequent undercut banks, large woody debris and eight spring inputs also contribute to good quality brook trout habitat. The largest spring just south of Sherwood Rd was contributing 300,000 L·day<sup>-1</sup> in July 2014; that value represented 20 % of the total flow in the western branch, from the spring outlet to the Charlottetown Bypass Highway (Figure 2.2).

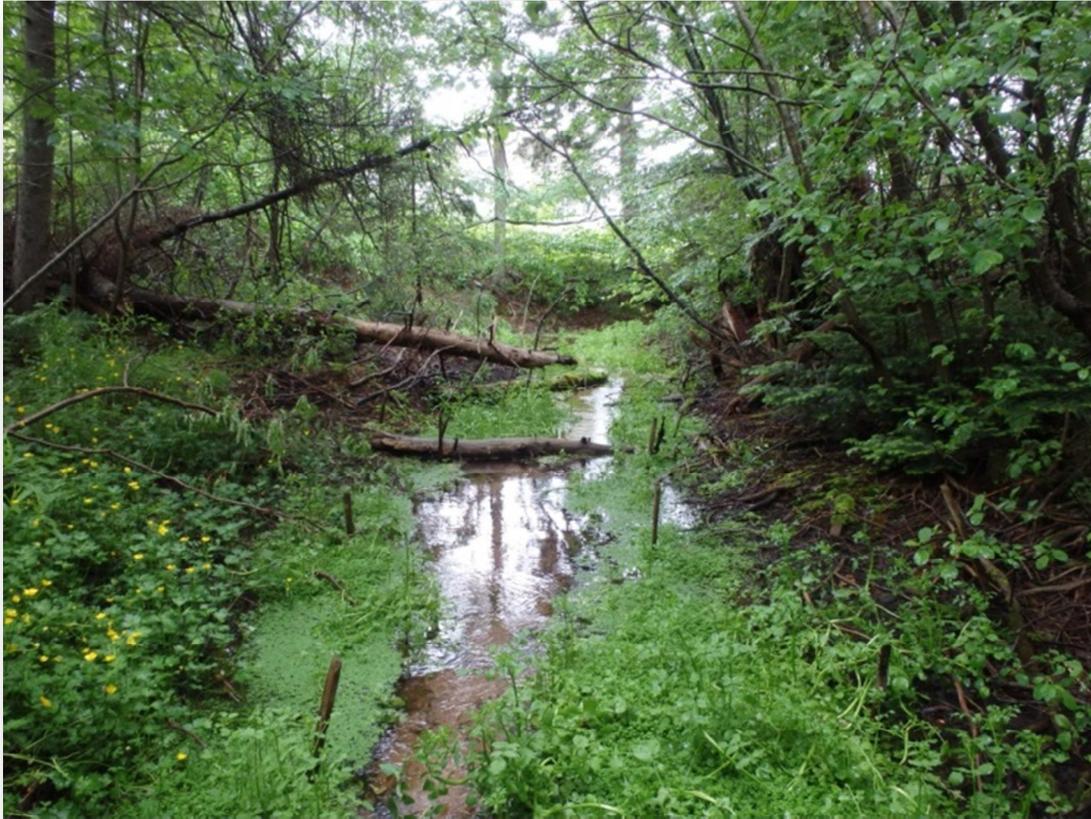
*Figure 2.2 A large spring contributing 20% of baseflow to this section of Ellen's Creek during the summer months (Photo courtesy of Norman Dewar)*

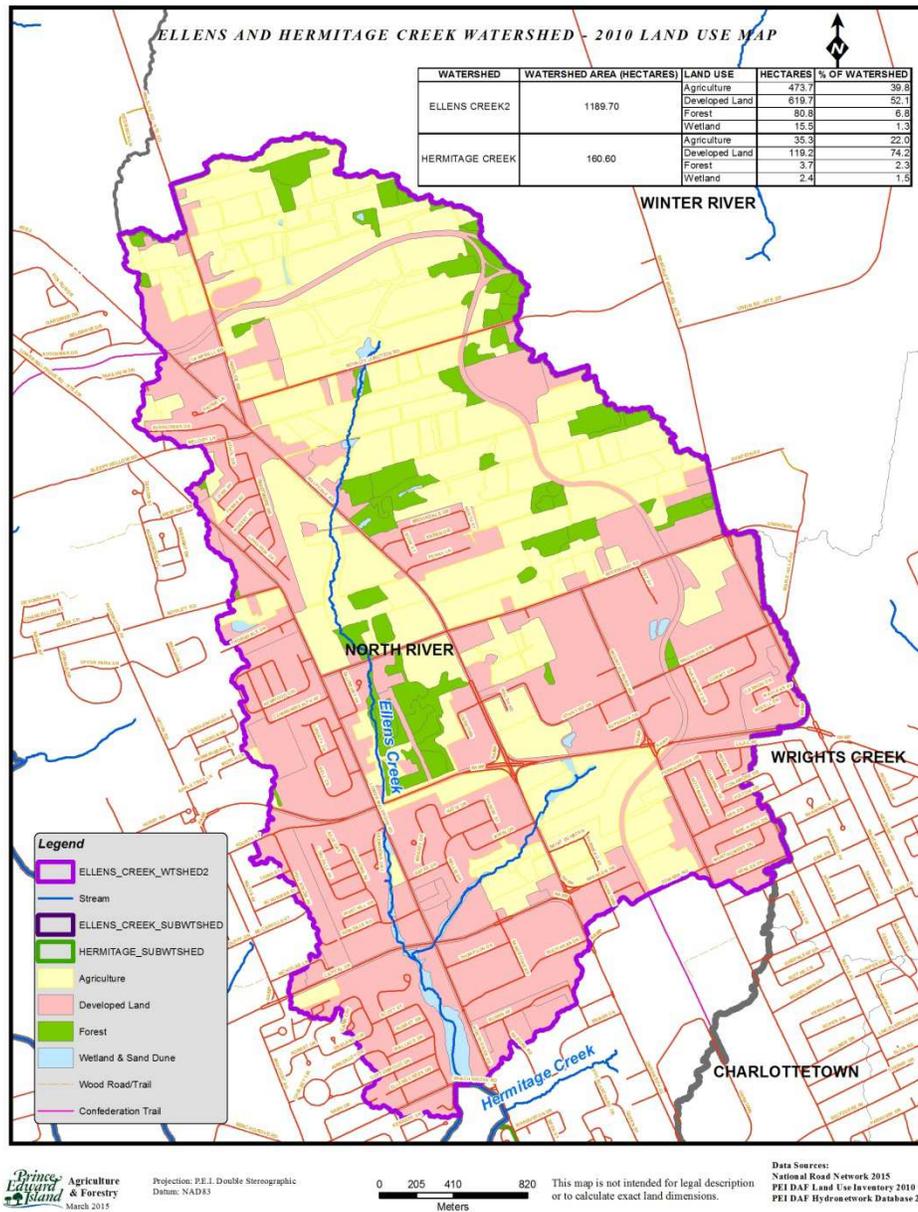
Figure 2.3 Land use in the Ellen’s Creek watershed according to 2010 aerial survey data (courtesy of PEI Department of Agriculture & Forestry – Forest, Fish and Wildlife Division)

The most recent land use census was derived from 2010 aerial surveys of the province. It indicated that Ellen’s Creek watershed in 2010 was 52 % developed land, 39.8 % agriculture and 6.8 % forest (Figure 2.3). Since that time, residential development has continued and it is likely that most has occurred at the expense of previously agricultural land.

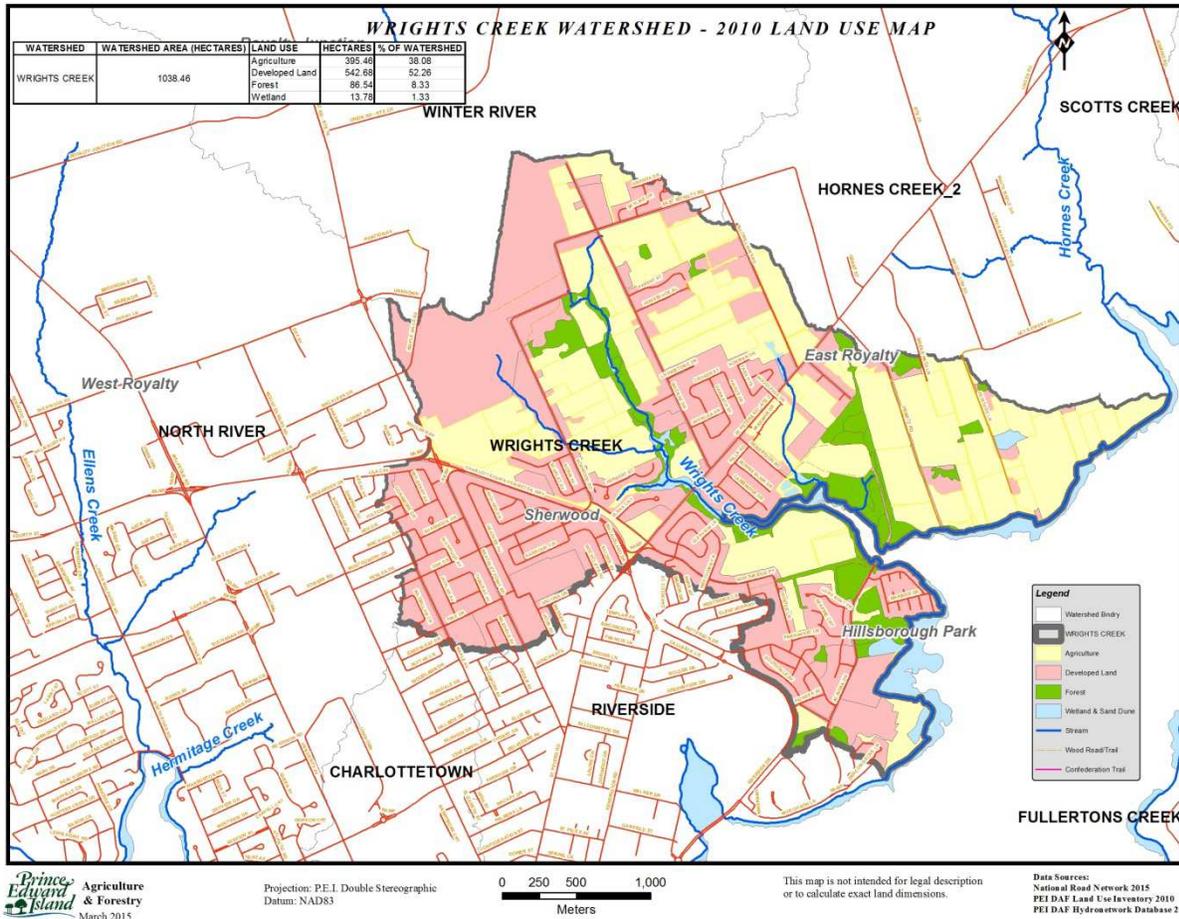
Figure 2.5 Land use in the Wright’s Creek watershed according to 2010 aerial survey data (courtesy of PEI Department of Agriculture & Forestry – Forest, Fish and Wildlife Division)

agricultural land are similar to Ellen’s Creek, at 52.3% and 38.1%, respectively (Figure 2.5).

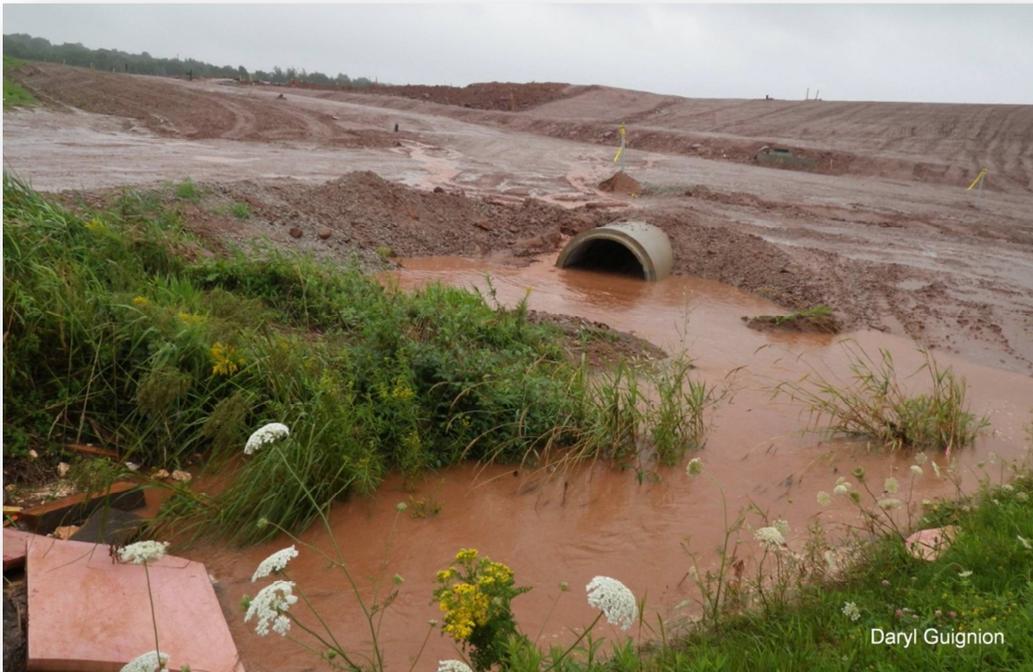
*Figure 3.1 Inadequate storm water runoff control at the construction site of the new Sobeys Mall off Malpeque Rd in 2011 during an intense rain event allowed sediment to flow directly into Hazard Creek*

The Ellen's Creek, Hermitage Creek, Hazard Creek and Wright's Creek watersheds all have issues with "red" water and excessive sedimentation. While there is some agriculture in the headwaters of Ellen's and Wright's Creeks, much of this farmland is not routinely tilled (e.g., it is in pasture and/or perennial crops). The drivers for this problem in an urban landscape are typically inadequate storm-water management and lack of best management practices in the residential and commercial construction industries (Figure 3.1).

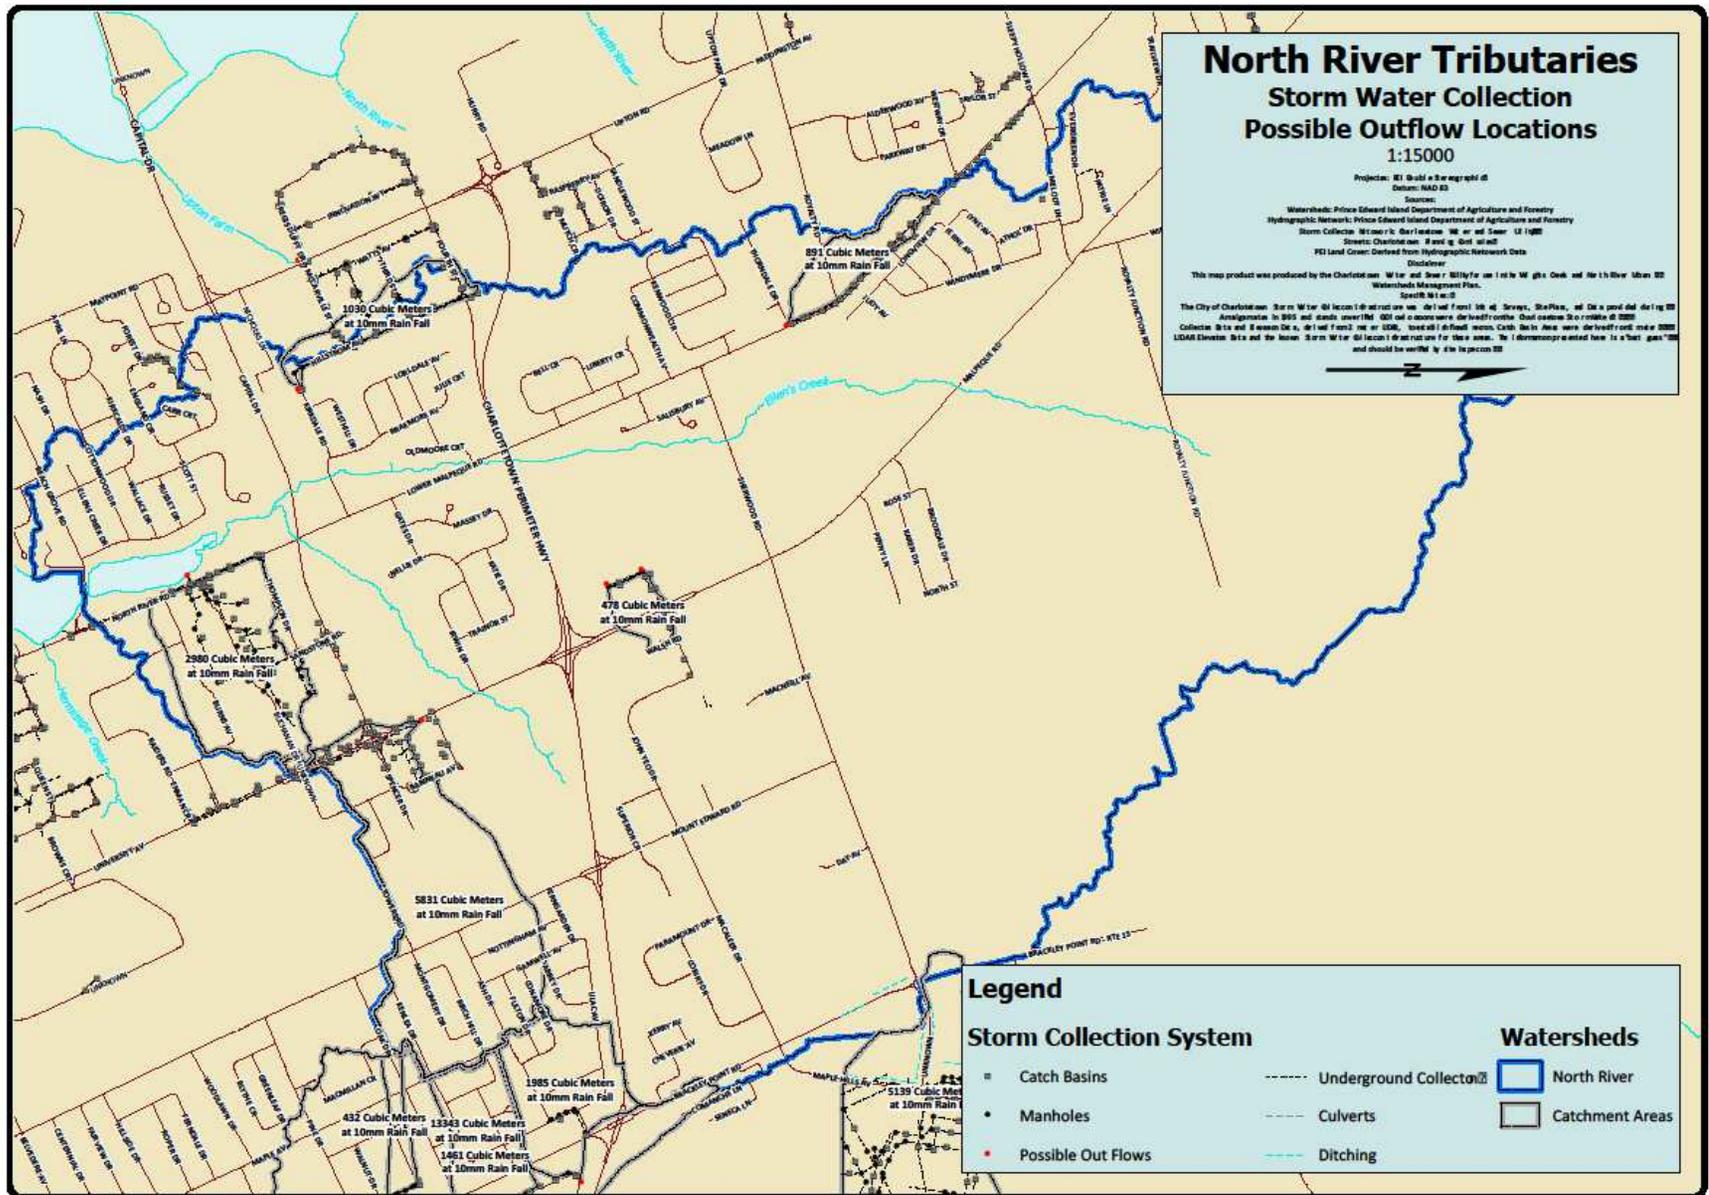
Figure 3.2a Map of known locations for storm-water discharges to Ellen’s Creek (courtesy City of Charlottetown). Water volumes are estimates based on collection area and a 10 mm rainfall event

Storm-water in several instances is channelled to these four urban creeks in Charlottetown, dramatically increasing peak flows during intense rain and snow-melt events (Figure 3.2). In addition, when the Charlottetown Airport was expanded, land that would normally have drained into the Winter River watershed had surface runoff diverted into Wright's Creek, further increasing the storm-water load to that freshwater system. While the primary objective of a storm-water system may be to divert water away from roads, homes and businesses, it can create more problems downstream if peak flows are not moderated. Erosion and sediment deposition is one ecological impact, but culvert loading is another that is of concern in these Charlottetown systems. Most if not all of the existing culverts are unable to accommodate the more frequent and intense precipitation events we are now experiencing with climate change. Figure 3.3 is one example from Ellen's Creek (2008) of the pressure put on existing infrastructure when a storm-water system is not designed to handle our changing weather patterns.

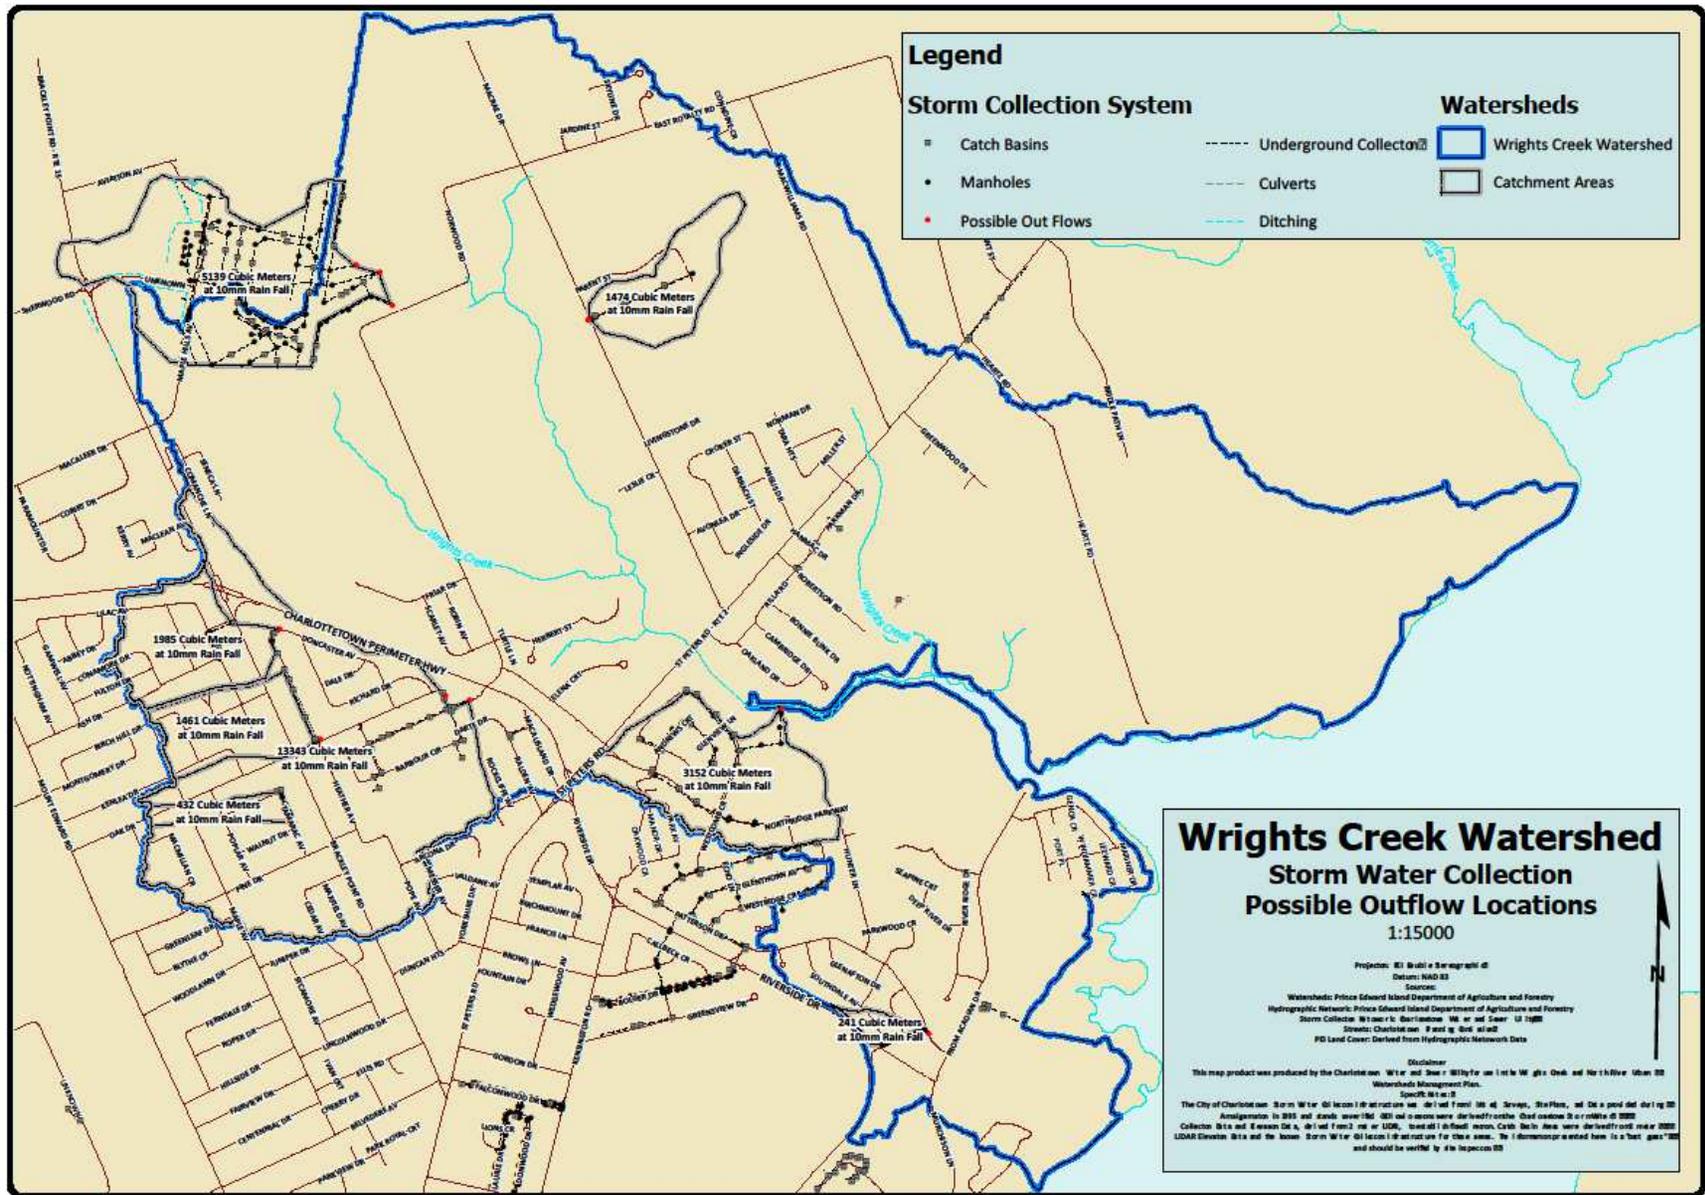
Figure 3.2b Map of known locations for storm-water discharges to Wright's Creek (courtesy City of Charlottetown) Water volumes are estimates based on collection area and a 10 mm rainfall event

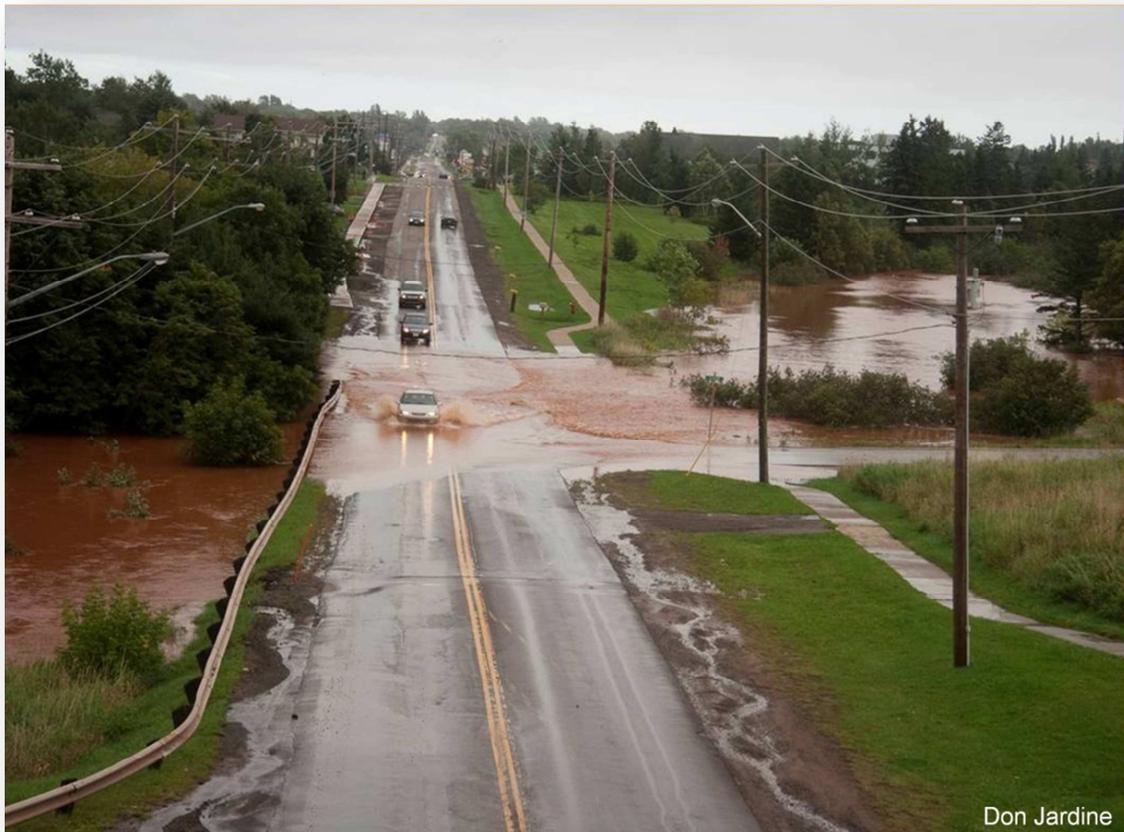
Figure 3.3 Flooding of Lower Malpeque Rd in the Ellen's Creek watershed during an extreme rain event in September 2008

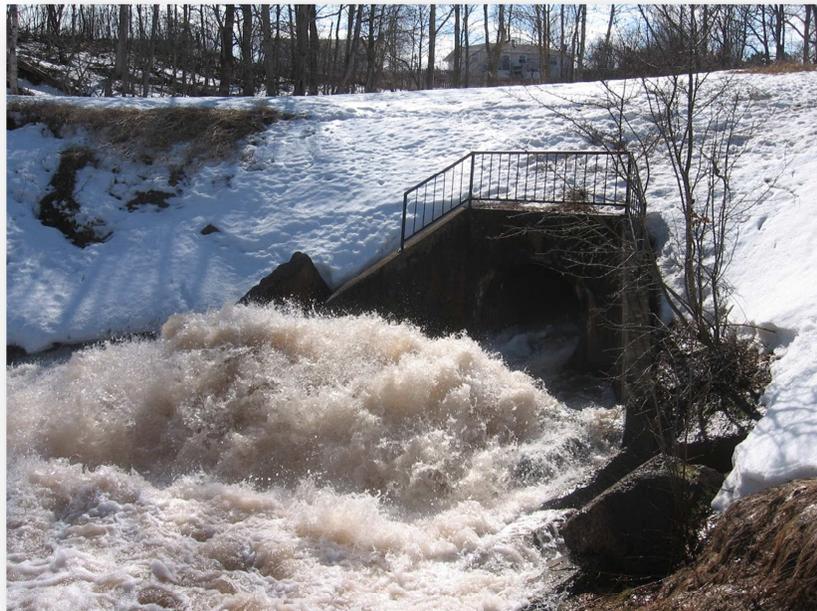
*Figure 3.4 Dam at Andrew's Pond, Wright's Creek watershed (photo courtesy of John Andrew)*

Within the three City watersheds there are seventeen culverts at public and private road crossings. Ellen's Creek has the majority, with 7 public and 3 private culverts (and an additional private crossing recently blown out and not replaced). Wright's Creek has 5 public culverts, but also a private dam at the head-of-tide which currently blocks all fish passage to the 12-acre Andrew's Pond and 1 km of upstream habitat (Figure 3.4). While the potential for a fish ladder at the dam has been investigated, it would be difficult and costly to instate, and would only allow partial access (for some sea-run brook trout but not for rainbow smelts or other weak swimmers). Hermitage Creek has 2 public culverts, but the upper-most one acts more like a dam in that it is a vertical, drop-inlet culvert that impounds water to maintain a small pond. There is no fish passage possible with drop-inlet culverts.

At this time, the construction of a fish ladder at Andrew's dam is considered too expensive and unjustified given the amount of brook trout habitat upstream from the dam (~2 km). There is not enough available land to create a by-pass channel. Stocking in Wright's Creek should be conducted in tandem with electrofishing monitoring to ensure that stocked fish are surviving.

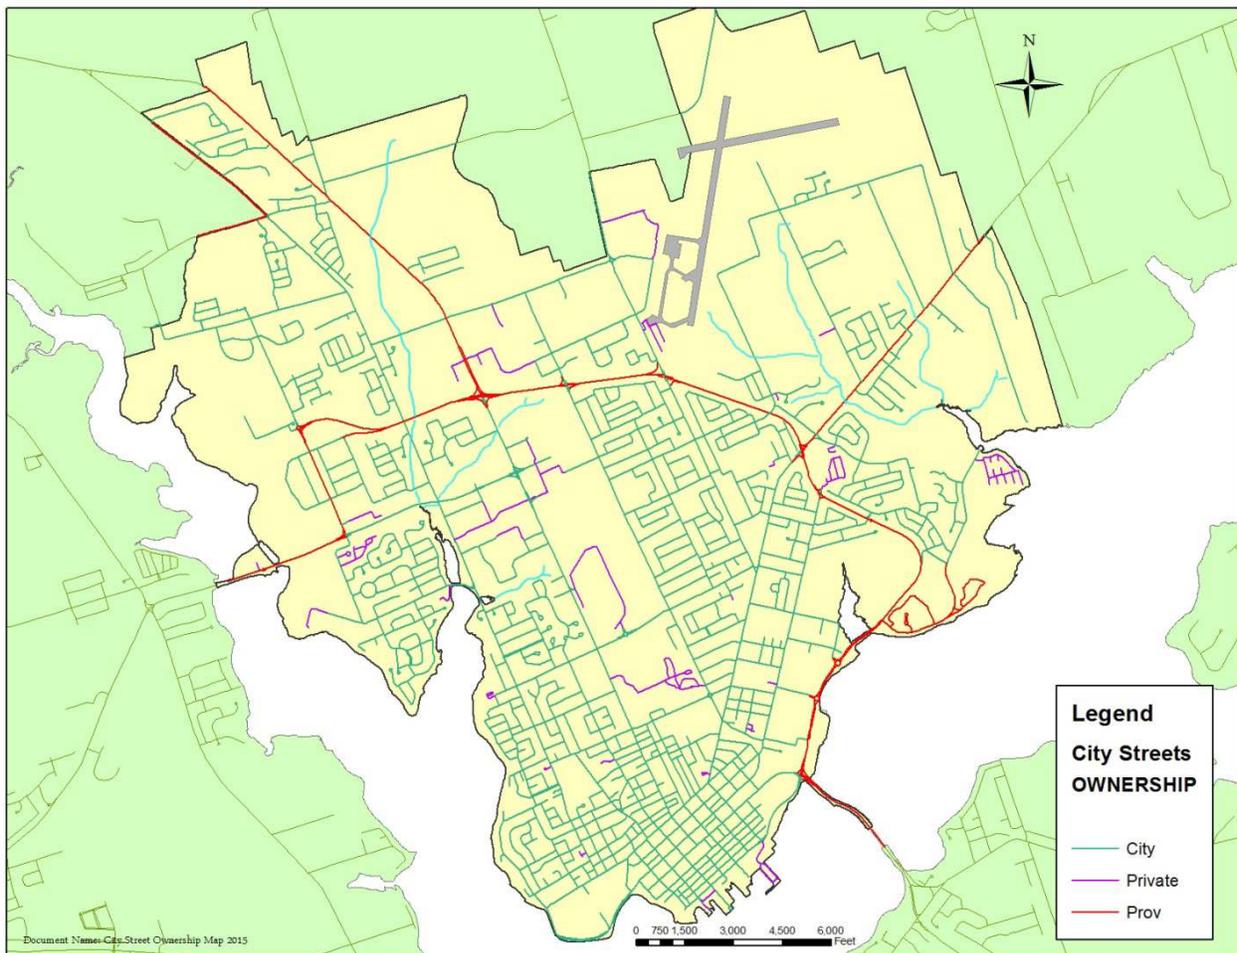
Figure 3.5 Map of Charlottetown showing jurisdictional division of responsibility for maintenance of public roads, culverts and bridges

past storm events, all but the Bypass culvert are under-sized for the present and projected future climatic storm flow loadings, and are nearing the end of their structural design. With the exception of the large concrete box culvert under the Bypass, all the culverts are aging and beginning to show signs of failure. A sudden road failure has a significant impact to the travelling public, public safety, the environment, and the economy. An example of a recent sudden catastrophic crossing failure within the City was the Sherwood Road which blew out on December 10, 2014. Debris from the crossing failure in-stream below the repaired roadway is presenting problems for fish passage and is backing up water into the culvert. The responsibility for maintenance of public road crossings is now split between the City of Charlottetown and the Province (Figure 3.5). As these structures begin to fail and are replaced, federal legislation (enforced by Fisheries and Oceans Canada) will require that fish passage be considered in the new design.

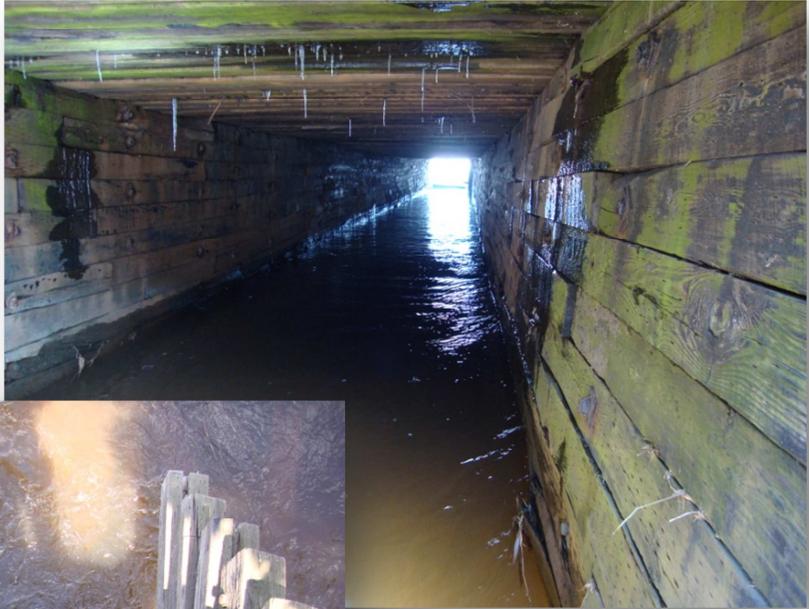
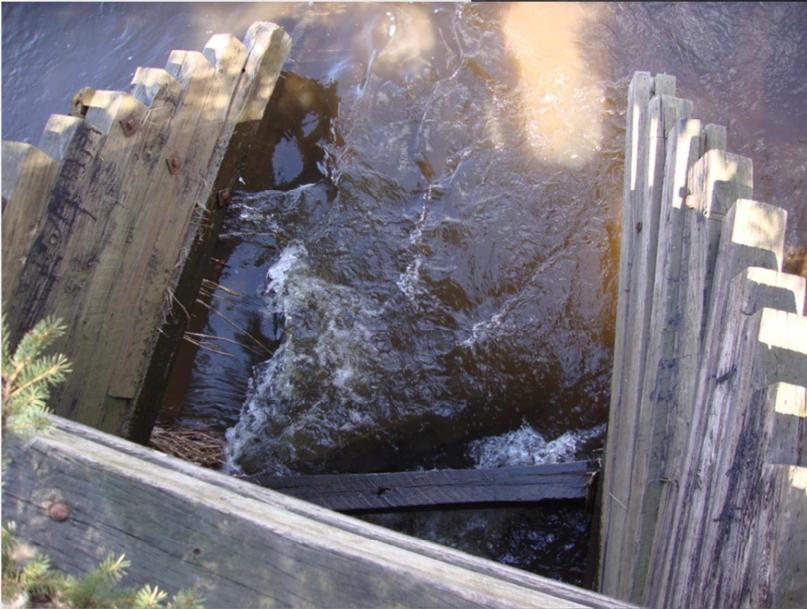
### Capitol Drive box culvert:

Downstream end (right),  
upstream end (below) with  
lowest timbers swung  
crosswise and sides  
collapsing inward

Location	Type	Size	Condition	Foreslope	Road Surface	Baffles Present	Fish Passage	Comments
<b>Capitol Dr</b>	Box creosoted wood culvert	8' diameter (square)	Poor; undermined at top east edge, timbers collapsing inward, sagging in middle	Soil & grass	Paved	No	Uncertain, partial	Deteriorating – stream at top entering at a 90 degree angle, causing erosion of banks, timbers swung cross-wise at entrance, no floor left inside
<b>Capitol Dr x North River Rd (Hazard Creek)</b>	Mix – wooden box, concrete arch or round culvert	5' diameter concrete (upstream), 4.5' square box (downstream end)	Unknown; concern about junction of round with box culvert under road	Soil & grass downstream edge is slumping	Paved	Unknown	Uncertain, partial	Two types of culvert must meet under the intersection somewhere
<b>Private Road Crossings</b>		* Last 3 private crossings not accessible at time of survey						
<b>339 Malpeque Rd</b>	Round corrugated steel culvert	3' diameter	Poor; breached & in pieces	Soil, clay	Clay	No	No	Old Mol homestead, breached in Dec/14 by DTIR

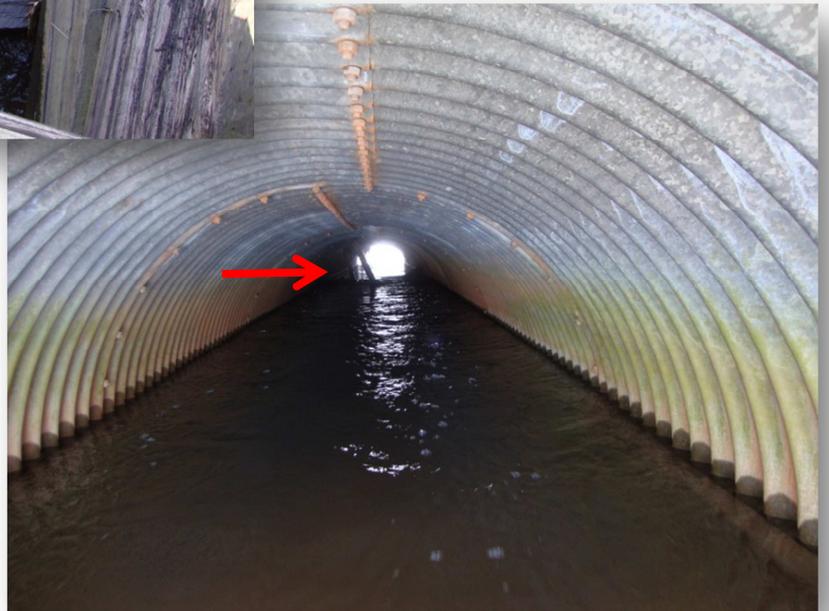
### Kirkdale Rd steel half round culvert:

Downstream end with debris jam  
midway through (right)

<b>Lower Malpeque Rd</b>	Half round corrugated steel culvert	Unknown, not visible	Poor; under-sized, at capacity	Soil & grass	Paved	No	Uncertain, partial	Road is low, stream coming over road at times, shoulders giving way
<b>Kirkdale Rd</b>	Half round corrugated steel culvert	8' diameter	Fair; debris blockage midway	Soil & grass	Paved	No	Uncertain, partial	Wooden floor in poor condition

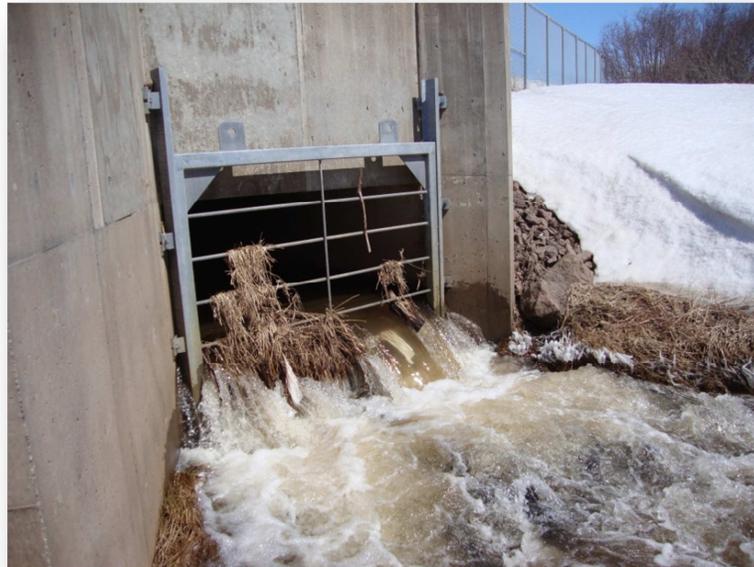
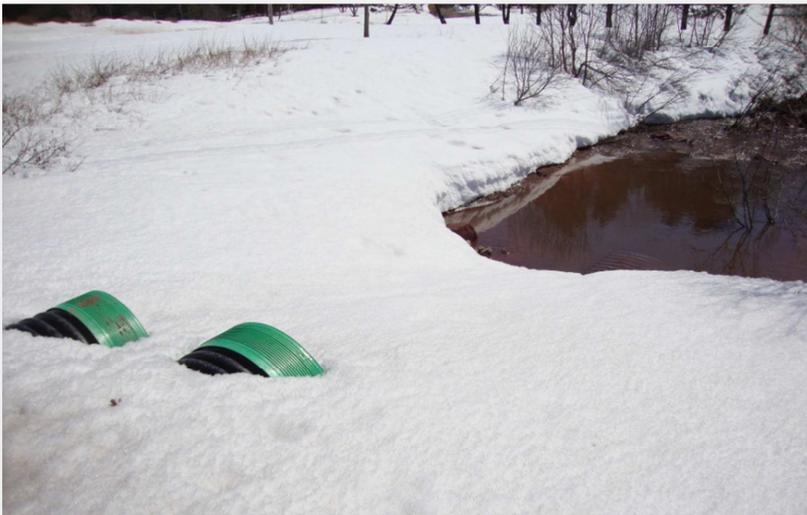
Charlottetown  
Bypass concrete box  
culvert:

Wood & grass debris  
collecting on grates  
at downstream end,  
increasing the water  
level within the  
culvert (right)

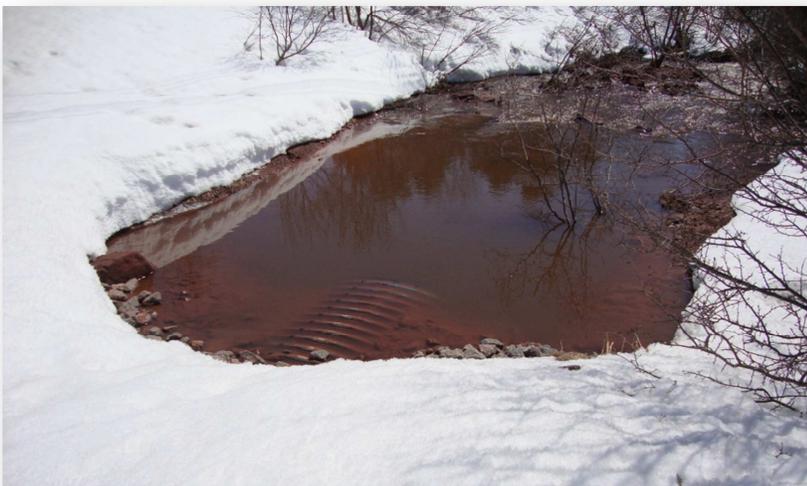
Sherwood Rd steel half  
round culvert:

Downstream end showing  
2 small overflow culverts  
(left)

Downstream end showing  
debris from blow-out  
altering stream course  
and backing up water into  
at-capacity main culvert  
(right)

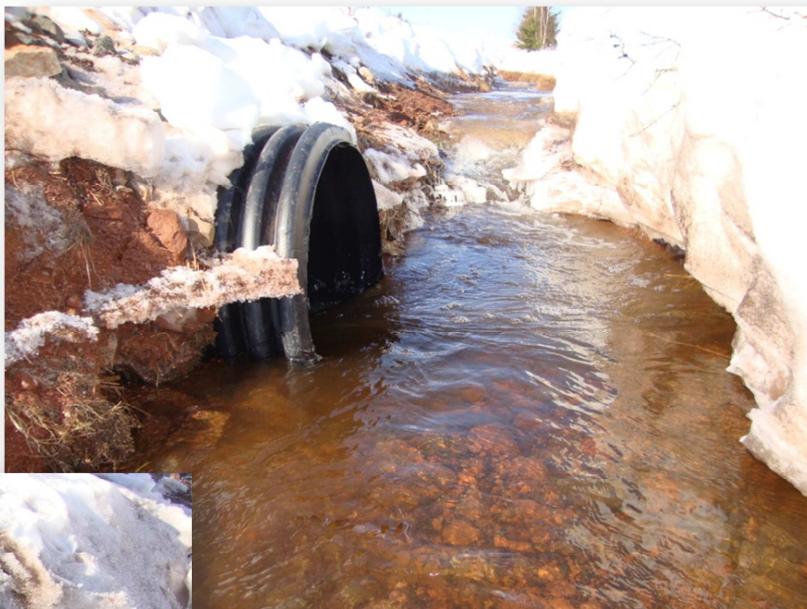
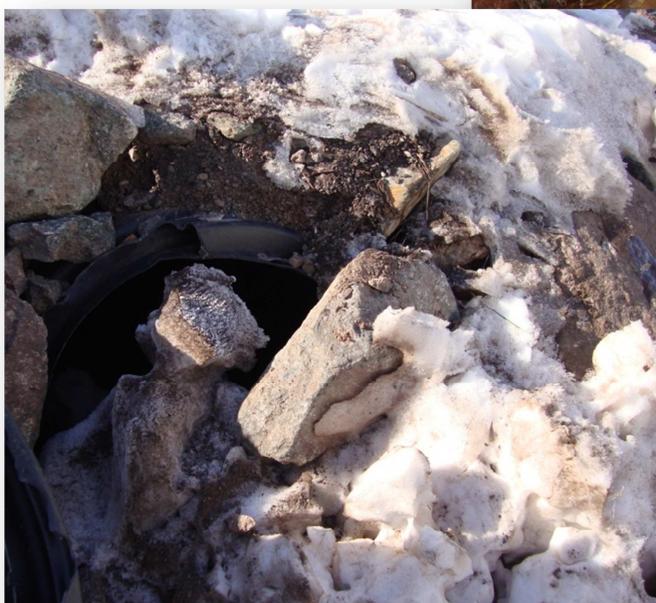
Royalty Junction Rd PVC round culvert:

Upstream end with storm-water and stream inputs (right), upstream end overflow culvert with rock blocking entrance (below)

Location	Type	Size	Condition	Foreslope	Road Surface	Baffles Present	Fish Passage	Comments
<b>Public Road Crossings</b>		All except the Charlottetown Bypass box culvert are the responsibility of the City of Charlottetown						
<b>Royalty Junction Rd</b>	Round PVC culvert	3' diameter 51' long	good	Rocks, gravel (rough, looks temporary)	Millings, poor condition	No	No, seasonal water flow only	2' overflow culvert beside, blocked with rock
<b>Sherwood Rd</b>	Half round corrugated steel culvert	5' diameter	Poor; under-sized, at capacity, blew out in Dec/14	Gabion baskets, rock	Paved	No	Uncertain, debris in-stream below from blowout may block access	2 overflow culverts above; repairs unfinished; large storm-water pipe enters directly above culvert
<b>Charlottetown Bypass (Provincial)</b>	Box concrete culvert	10' diameter	Good but grates are catching debris	Rocks	Paved	No but boulders placed inside	Uncertain, partial	Spacing between boulders inside long culvert impacts passage of fish

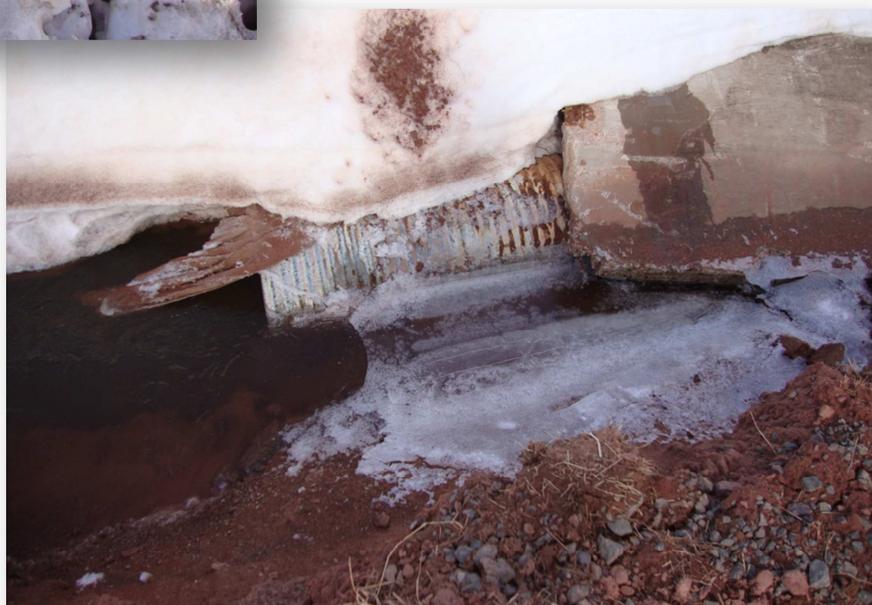
Breached culvert at old Mol homestead:

Corrugated culvert pieces and concrete slabs in-stream (right), other pieces scattered on banks downstream with rock & sediment
